Review on Failure Analysis of Cooling Tower Fan Gearbox

Abstract- In this paper, the failure of pinion gear has been selected as investigation topic. However, this study also includes the failure analysis of gearbox of cooling tower fan. A gear is used to transmit torque. Gears are generally like worm gears, spur gears, helical gears, rack & pinion, herringbone or a double helical gears, hypoid gears, bevel gears etc. The various applications of these gears are varied from small wrist watches to massive machinery such as aerospace industry, automobile, rolling mills, transmitting & hoisting machines, marine engines, and etc. The problem identified here is the pinion gear in the fan gear box is failing prematurely; the life of the gear is less than 1 month. Pinion gear was observed during the visual inspection and it was found with broken teeth. After completion of this project, the solution found on the problem will increase the life of pinion gear as well as the gear box.

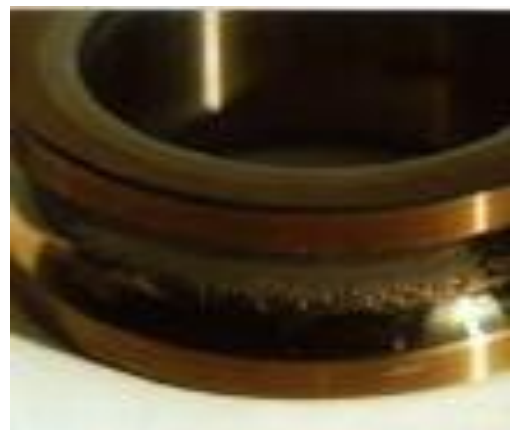
Bearings are working under variable, high load and undesirable environmental conditions. Due to the force applied to bearings the defects often developed quickly and cause to friction, bearing damage as well as gearbox failure. [12]

Fig 1: Defects in the bearing[12]

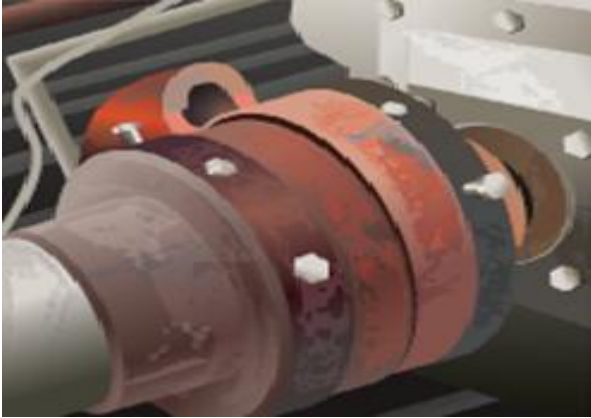
The length of the shaft in a cooling tower fan is quite large because of this misalignment of the shafts is a common problem. Due to the stress in the shaft can damage couplings which cause for bearing fatigue, and lead to breakage of the shafts. [12]

Fig 2: Misaligned shafts[12]
